Manhole Inspection Summary

Manhole # S3500_038MH

Insp Date: **1/26/07 9:05 AM**

Location Address: **2317 HARGROVE AL**

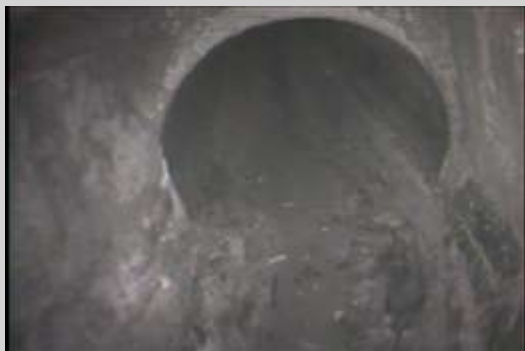
8 in. Circular Gravity Sewer Pipe In @ 3 O'Clock

Rod and Bar (Angled)

Pipe Material: **Clay** ☐ Pipe Lined

Invert Depth: **9.50** (ft.) Flow Characteristics: **Slow**

Deposits: ☒ None ☐ Mud ☐ Sludge ☐ Debris ☐ Grease

Infiltration: **None** Pipe Seal Cond: **Unknown**

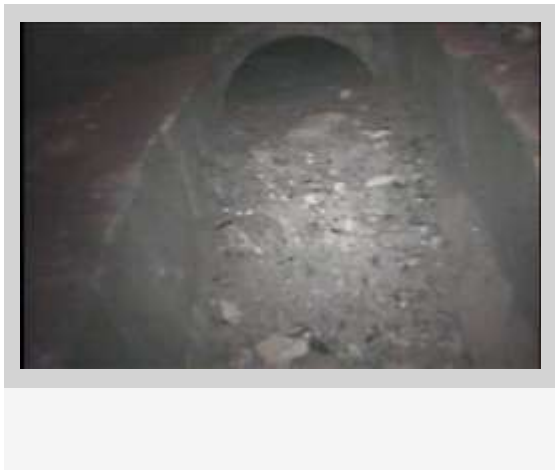
Pipe In @ 6 O'Clock

Pipe Material: ☐ Pipe Lined
Invert Depth: (ft.) Flow Characteristics: **None**
Deposits: ☒ None ☐ Mud ☐ Sludge ☐ Debris ☐ Grease
Silt Depth: (in.) Deposits Extent:
Infiltration: **None** Pipe Seal Cond: **Unknown**
